HSCA VII

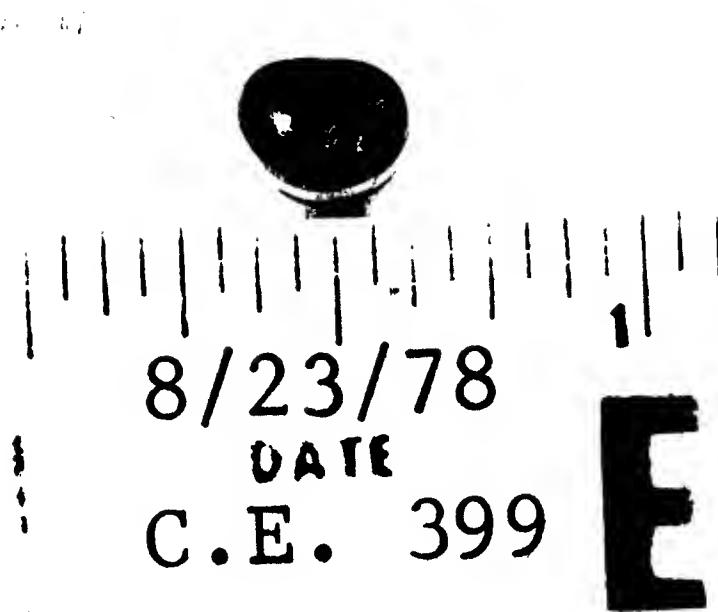
FIGURE 6B.—CE 399, the fired 6.5-millimeter caliber full metal-jacketed bullet found on a stretcher in the emergency area of Parkland Memorial Hospital, view of the base portion, showing distortion.

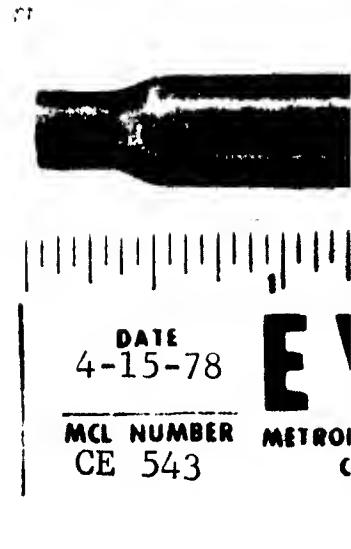
FIGURE 8A.—CE 543, one of three expended of Western Cartridge Co. manufacture, re Texas School Book Depository, side view.
